Beechcraft 1900C Vertical Impact Test

May 1999

DOT/FAA/AR-TN99/25

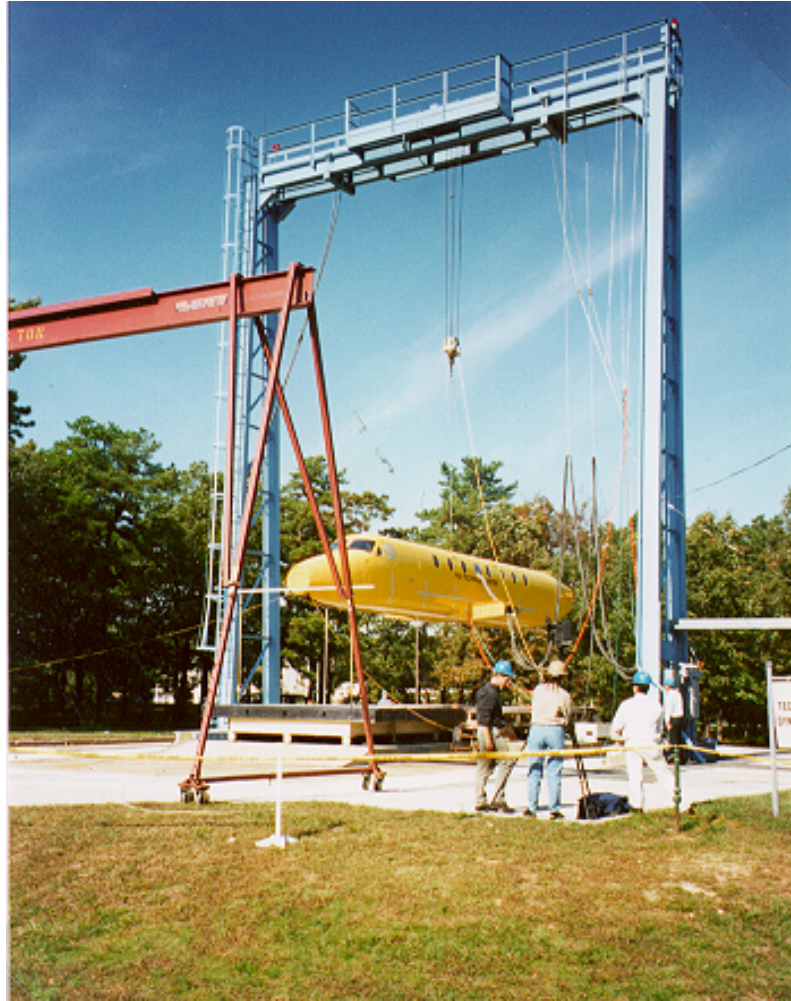
FIGURE 1. DROP TEST FACILITY

The William J. Hughes Technical Center drop test facility, shown in figure 1, is comprised of two 50-foot vertical steel towers connected at the top by a horizontal platform. An electrically powered winch, mounted on the platform, is used to raise or lower the test article and is controlled from the base of one of the tower legs. The current lifting capacity of the winch is 13,600 pounds. Attached to the winch is a reeved hoisting cable which is used to raise the test article. A sheave block assembly hanging from the free end of the reeved cable is engaged to a solenoid operated release hook. The release hook is connected to the airframe by a cable/turnbuckle assembly with hooks bolted to the fuselage section at four locations. Located below the winch cable assembly and between the tower legs is a 15- by 36-foot wooden platform which rests upon I-beams and is supported by 12 independent load cells.

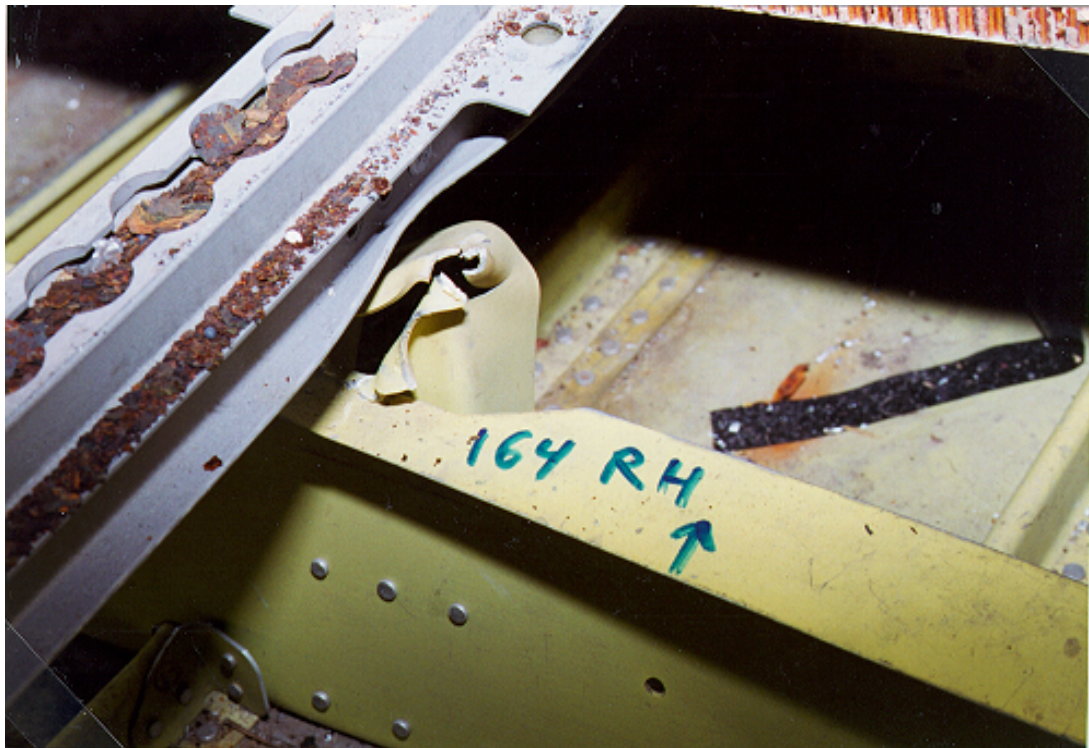
FIGURE 6. UNDERFLOOR BUCKLING RIGHT-HAND SIDE AFTER IMPACT

INTERNAL. The structural deformation experienced on the inside of the test article was minimal. The seat tracks remained intact and in place. Minor buckling was seen along the fuselage underfloor and side walls (see figure 6).

The still photographs in this report were taken with a 35-mm camera both prior to and following the drop test. Examples of these photographs are seen in figures 5 through 7.
